Damage Development Mechanisms in Notched
Graphite Epoxy Composite Laminates during
Compressive Fatigue Loading

Virginia Polytechnic Inst. and State Univ.
Blacksburg

Nov 81

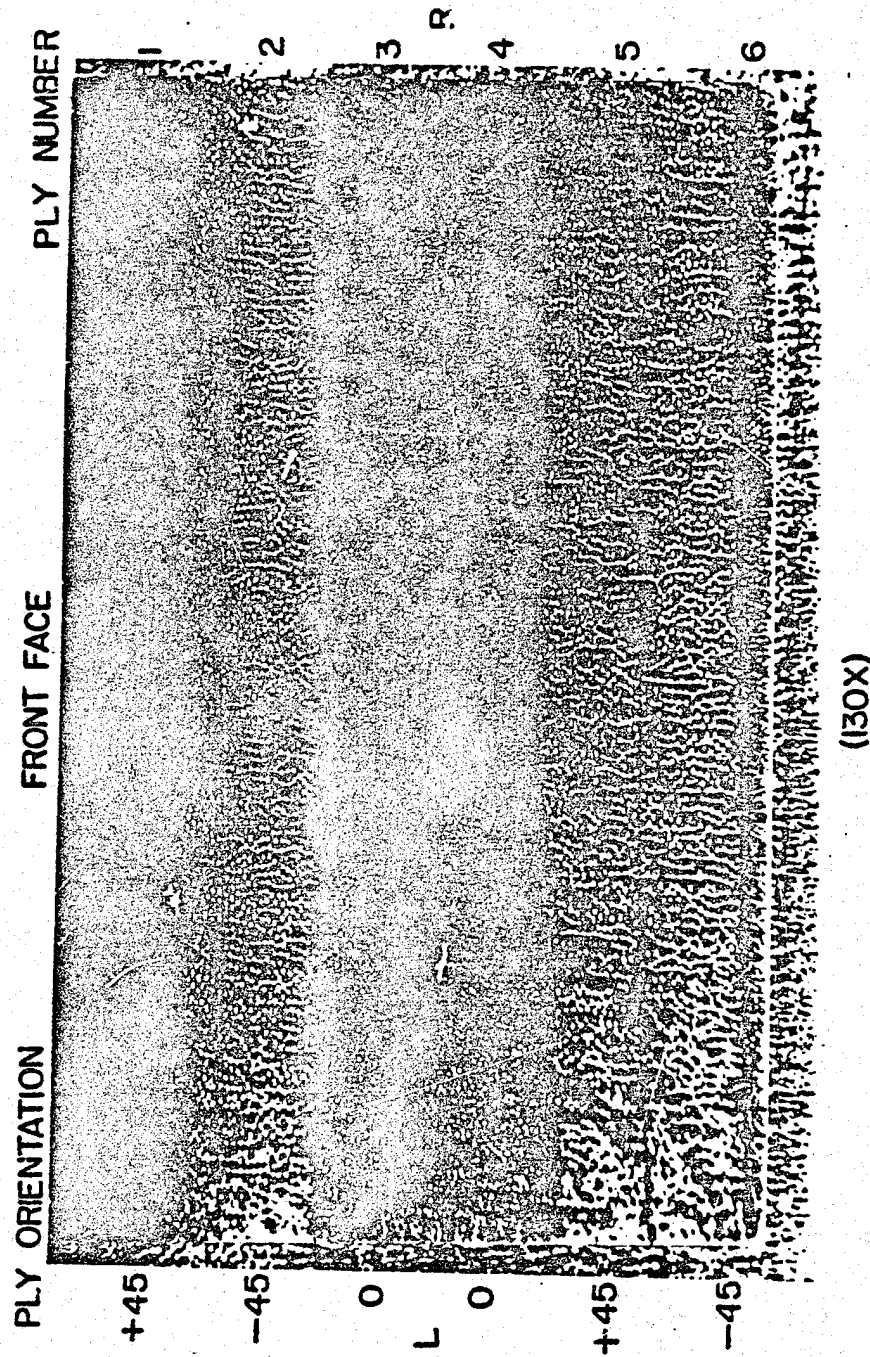
Figure 37. Light micrograph of the fourth transverse section of specimen 1-6 showing matrix cracking and delamination in zero deg. plies.

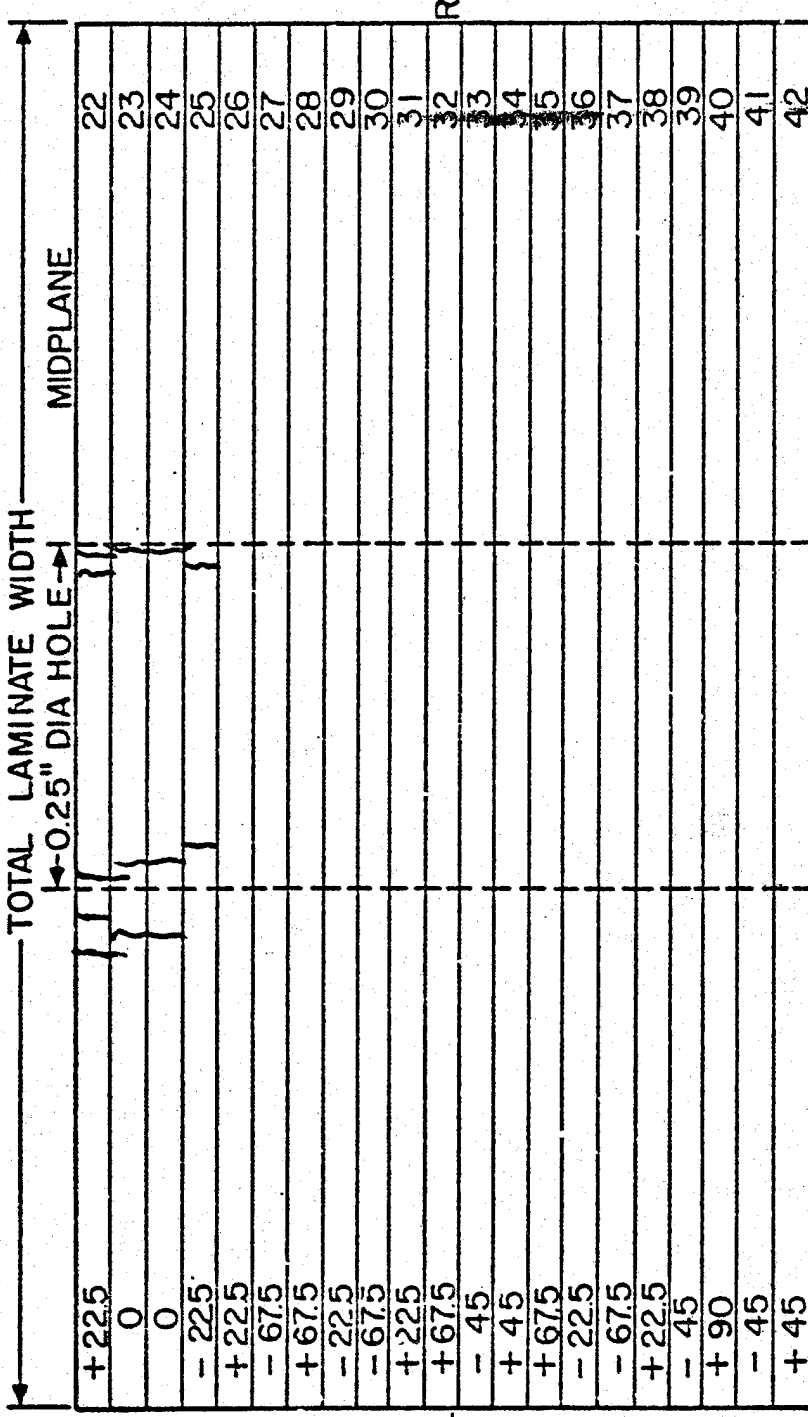
Figure 42B. The first transverse section of specimen 1C2 (42 ply) showing damage detail.
